Technical Bulletin

TITLE: HVT 2.0 Instructions for Use Update

DOC #: TECH-00050 Revision: A Page **1** of **2**

Subject: This Bulletin serves as an update to your HVT 2.0 Instructions for Use:

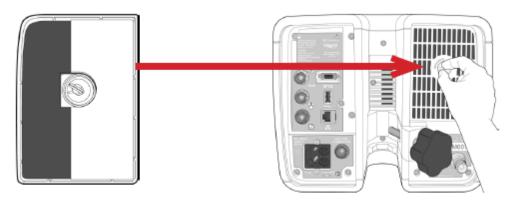
Figure 48: Insert patient air intake filter in back of device

Replace the Patient Air Intake Filter:

The patient Air Intake Filter should be inspected frequently for particulate contamination and replaced every 6 months or as recommended per your institution's policy.

- ✓ If this filter is discolored (typically gray or brown) replace the filter as soon as possible.
- ✓ Please ensure there is no liquid Ingress through the Air Intake Filter (e.g. refrain from spraying disinfectant on air Intake filter or inadvertently spilling liquid on the air Intake filter).
- ✓ Please ensure that the Air Intake Filter Is correctly orientated In the Filter Housing.

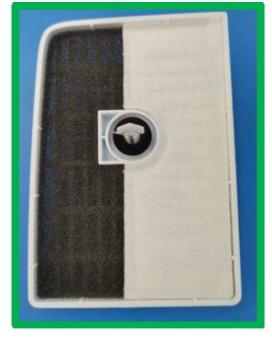
Incorrect Filter Orientation
